SHIPWRECKS OF SOUTH AUSTRALIA

ELENI K

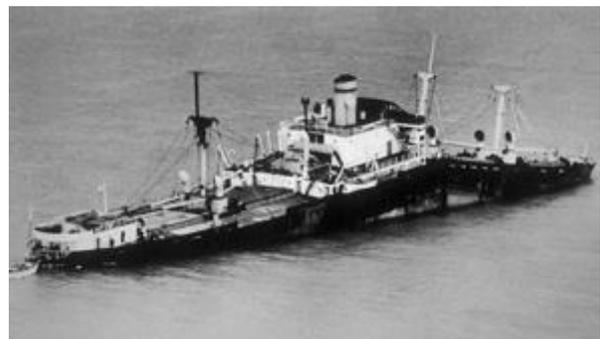
Aground at Thevenard, 1966. Photo: PortsCorp

Approximately 90 minutes after leaving port (and only 10 minutes after the pilot disembarked) the *Eleni K* broke its back and buckled in the area of the No 3 (or central) hold. The engines were stopped, and the vessel anchored, but sank soon after. In mid-October the German freighter *G / Nickelson* salvaged 1770 tons of wheat using suction equipment, under difficult conditions, but further salvage was halted on 25 October.

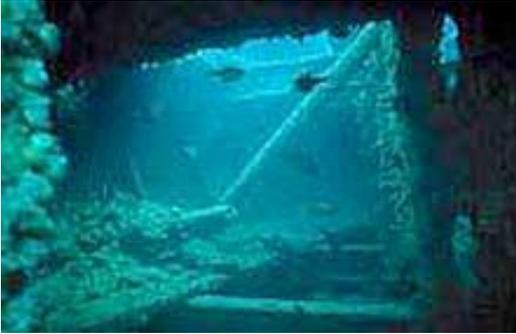
***Eleni K* today**

Winches and windlass are still sitting on the deck. The engine room, as well as other sections of the site, can be penetrated and the triple expansion steam engine and boilers are still standing in position. The hull and decks appear to be in a relatively intact state, although there are signs of the hull collapsing.

Today the extensive remains of the *Eleni K* provide one of the best shipwreck dives in South Australia. The relatively intact vessel is sitting upright, with the top of the bridge about two metres under the surface.
